LOG

FURNISHING WATER AT LIGHT STATIONS

By Wayne C. Wheeler

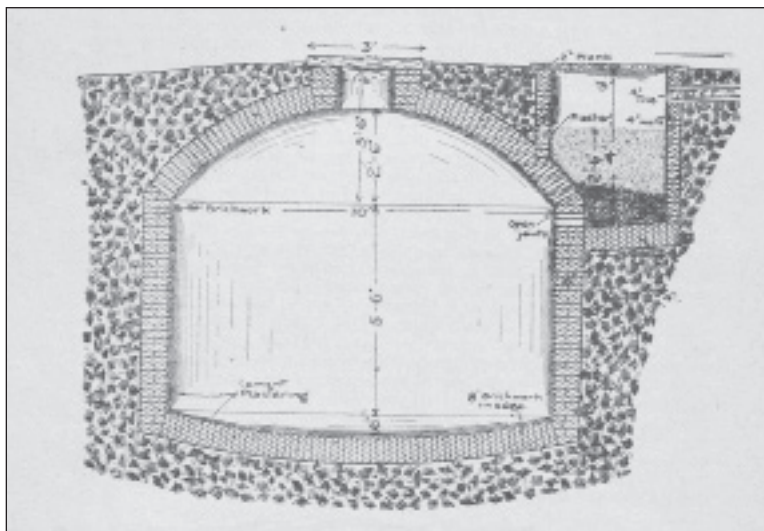
Drawing of an underground cistern from an 1895 pamphlet "Drinking Water in its Relation to Malarial Diseases." Public domain image.

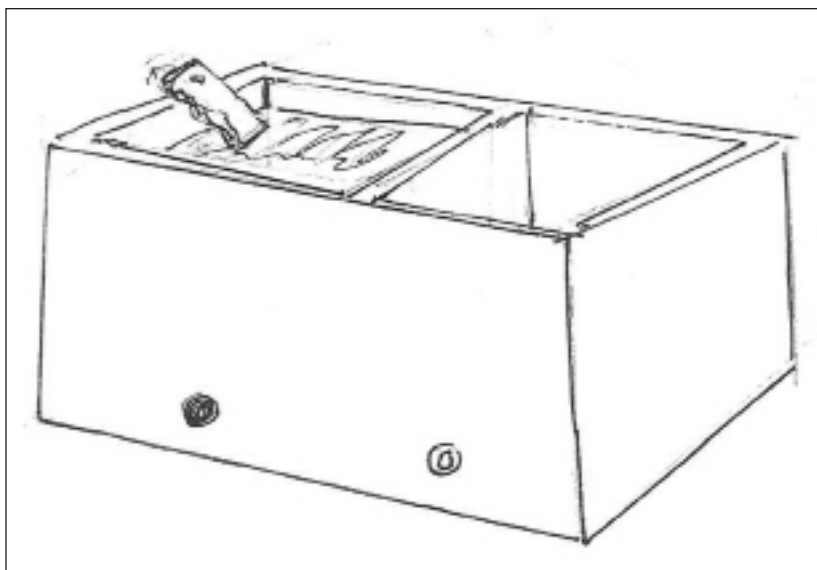
Left: A two-well concrete cistern. One compartment may be drained for cleaning while the other contains water. A board laid from the edge to the water allows vermin to escape. Drawing by the author.

Some cisterns or water holding tanks in the basements of dwellings consisted of a large open concrete tank divided into two compartments. This allowed the keeper to drain one for cleaning while the other retained water. Keepers sometimes floated a board in the water of a tank with one end resting on the side. This allowed any animal like a rat, mouse, or squirrel to exit the tank. After all, one doesn't want a dead rat in one's drinking water.

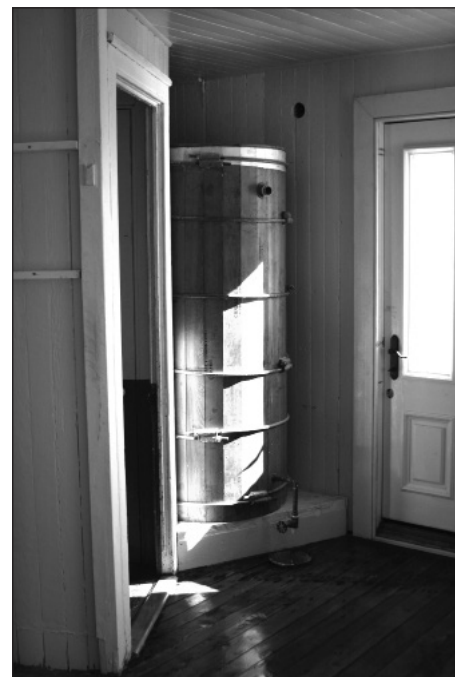
Below: Cistern at Thomas Point Shoal Lighthouse in Maryland. Photo by Henry Gonzalez.

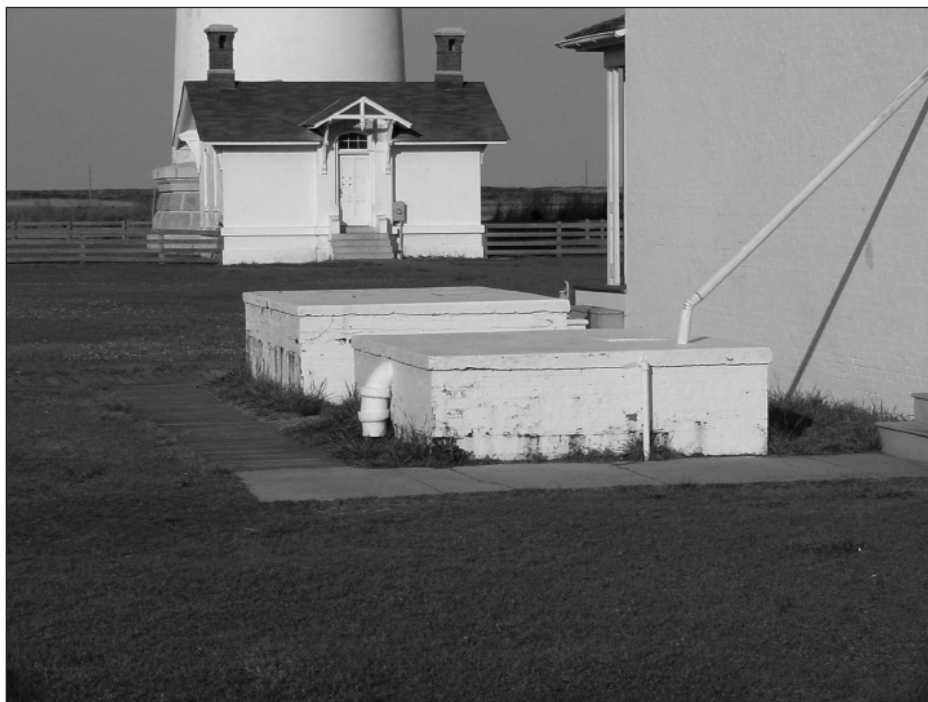
Cisterns at Bodie Island Lighthouse, North Carolina, 2002. USLHS archive photo by J. Candace Clifford.
